Unsolved problems of the material structure of the Doel 3 / Tihange 2 reactor pressure vessels.

prof.dr.ir.ing. René Boonen

K.U.Leuven

April 8, 2018

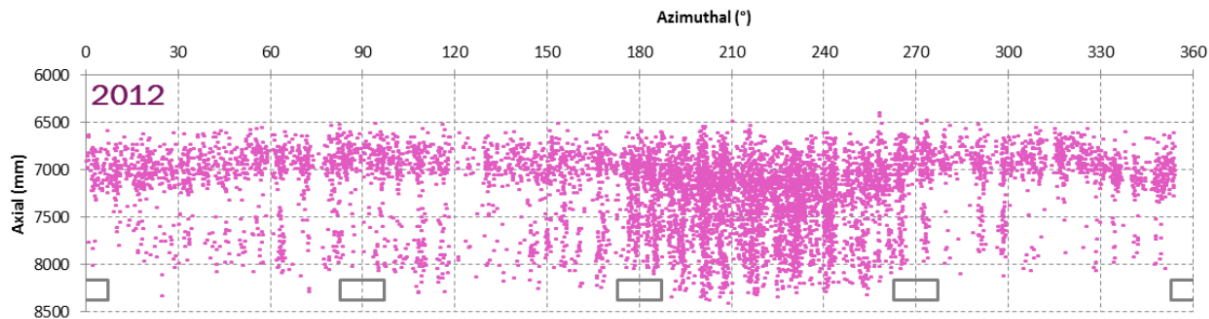
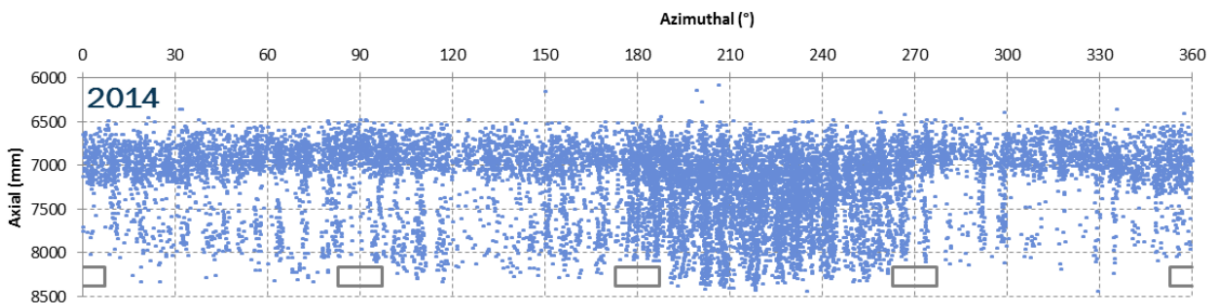
Lower shell 2012:7200/2014:11600 Upper shell 2012:800/2014:1400

Flaws distribution in the circumference of the Doel 3 lower core shell.

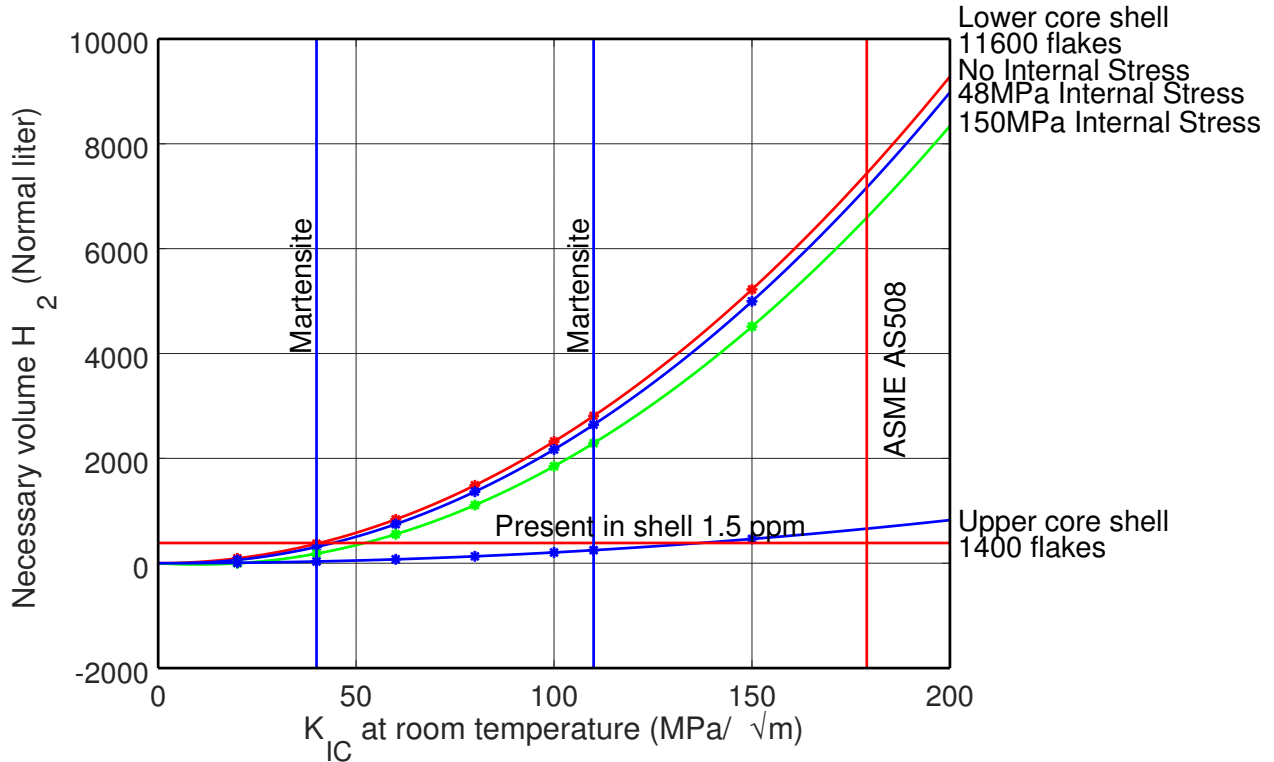
Required volume hydrogen to form all measured flakes.

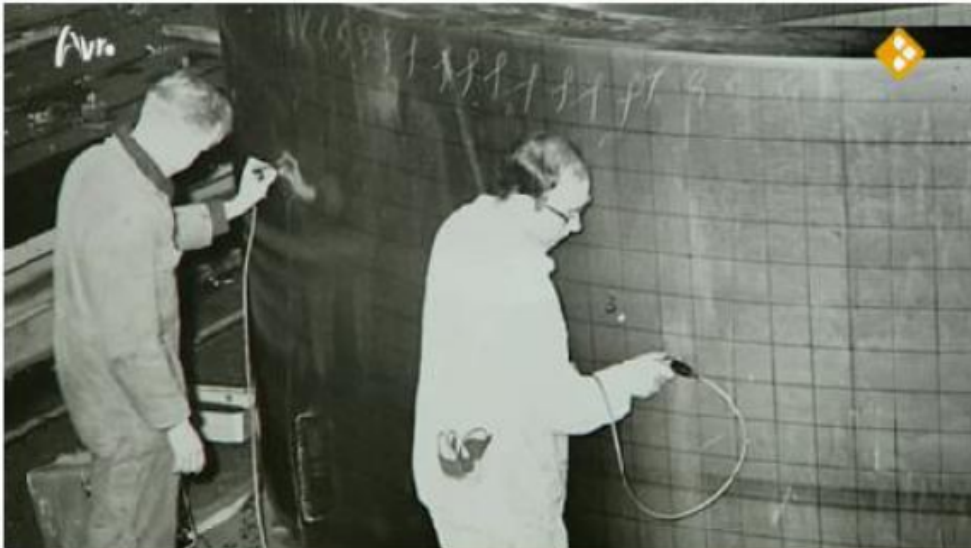
First ultrasonic test: not obligated, no results known.

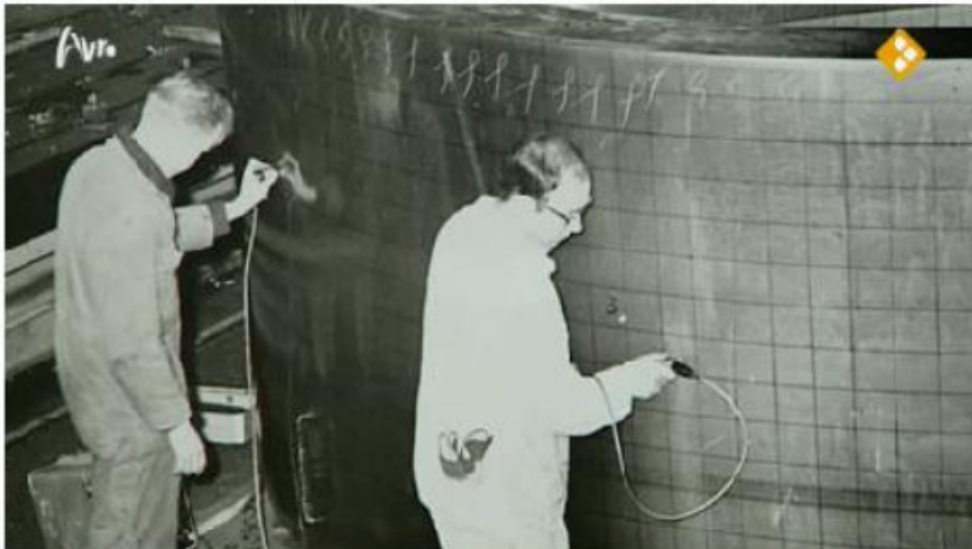
Upper core shell: reported zone with acceptable flakes.
Lower core shell: no reportable flakes.

Final ultrasonic test.
