Unsolved problems of the material structure of the Doel 3 / Tihange 2 reactor pressure vessels.

prof.dr.ir.ing. René Boonen

K.U.Leuven

April 8, 2018

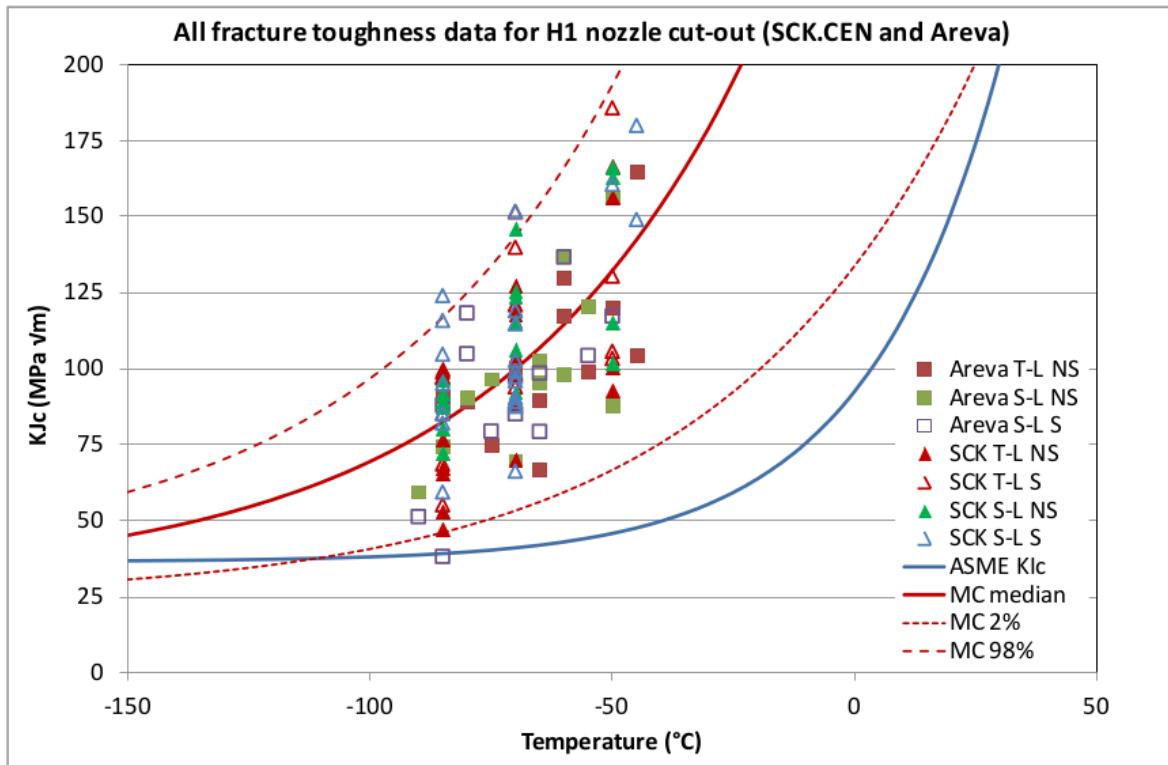
RT-curve AS508.

- Sufficient volume hydrogen.
- Material structure sensitive to flaking.
- Internal stresses perpendicular to the flakes.
- Flaking occurs during cooling below 200°C

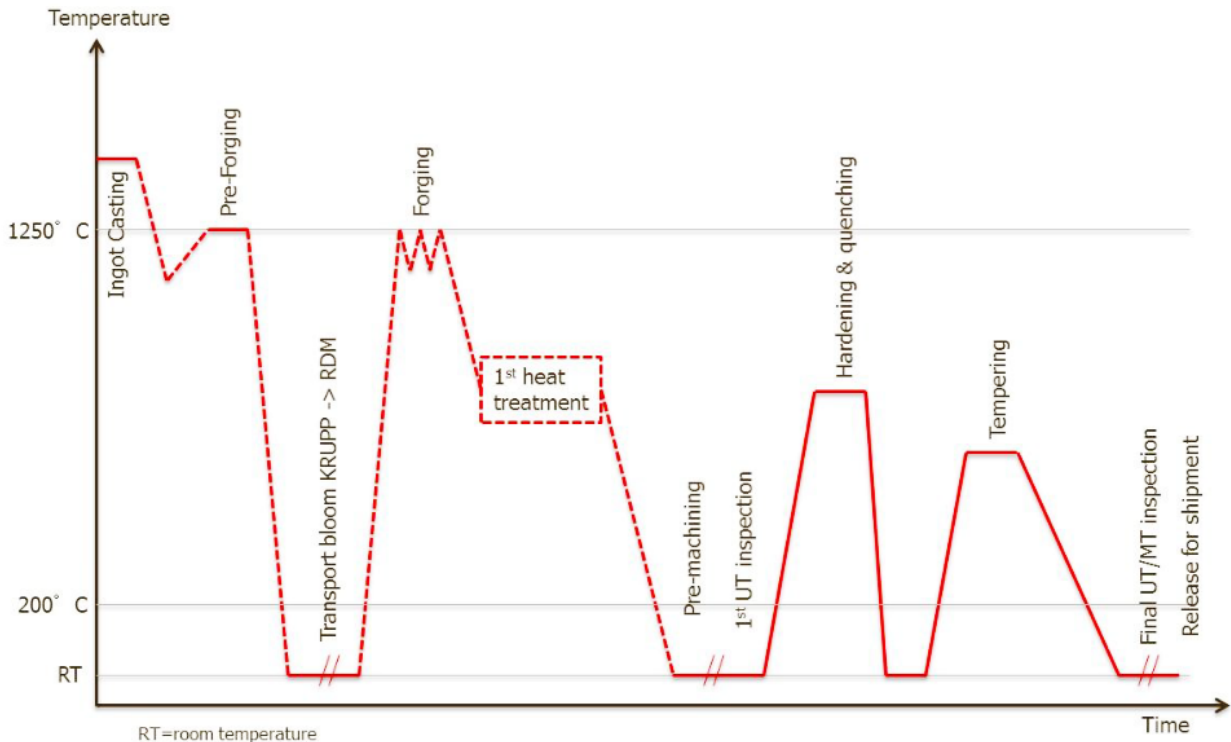
Required volume hydrogen to form all measured flakes.
